**Flood Control Project Maintenance
Levee Inspections**

Maintenance Issue Types Only, Levee Inspection Report By Mile - Spring 2017

Sutter Maintenance Yard East Levee Sacramento River

Waterway	Bank	Unit Miles	Inspection Start/End	Inspector
Unit No. 01 Sacramento River	Left	19.85	03/22/2017 03/22/2017	Bob Duffey

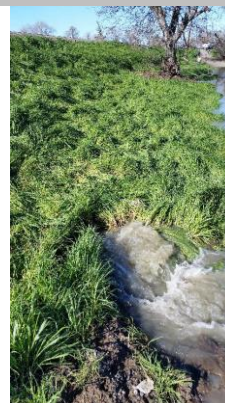
Photo 1 of 3 : UCIP_SP_2017_51665_76919.jpg

LS view of water exiting the pipe.

Comment Code					
Inspector Comment					
FS_ID:51665 DS_ID:17311 EP_NO: N/A Repair Type: Urgent Crossing Status: Found UCIP Comments: 4/6/2017 Pipe was found in January 2017 during a high water event when water uncovered the buried WS end which led to uncontrolled water flow through during the high water event. The WS pipe opening was temporarily blocked off by plywood and sandbags until the pipe can be properly plugged or abandoned. Pics updated. (DWR Sutter Yard- Afreitag)11/7/2016 Unable to locate. (DWR Sutter Yard- Afreitag)6/6/2016 Unable to locate.4/6/2015 Unable to locate.6/30/2014 Unable to locate.12/30/2013 Unable to locate.7/29/2013 Same as last inspection. Unable to locate. FIELD_STRUCT_DESC: *ABANDONED* 24-inch corrugated metal drainage pipe through the levee, 12.4 feet below the crown. Slide gate on the waterside (WS) end. Pipe silted over on both ends. (Automatic Board Order (ABO) issued as Permit No. 9539, 1974 - Locvich). [Additional Reference(s): DWR Levee Log, 2002. USACE Sacramento O&M Manual 136, March 1960 (HLM 3.25)]. FS Date: 4/26/2017 12:09:42 PM

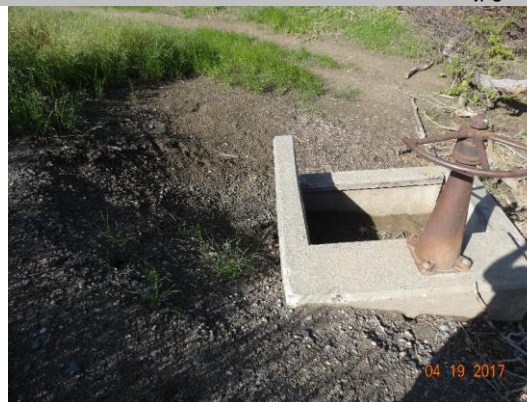
Photo 1 of 3 : UCIP_SP_2017_51695_77008.jpg

FS_ID:51695
DS_ID:17301
EP_NO: 9532
Repair Type: Non-Urgent
Crossing Status: Found
UCIP Comments: 4/19/2017 Abandoned- erosion/depression present around the WS box (DWR Sutter Yard- AFreitag)10/31/2016 Abandoned and erosion still present near WS box.(DWR Sutter Yard- AFreitag)6/1/2016 Appears to be an abandoned crossing.4/1/2015 Silted concrete box on WS. Depression/erosion around concrete box on WS.Silted concrete box on WS. Depression/erosion around concrete box on WS.6/30/2014 Same as last inspection.12/18/2013 Same as last inspection.7/23/2013 Same as last inspection.
FIELD_STRUCT_DESC: *ABANDONED* 36-inch by 48-inch reinforced concrete box drainage culvert through the levee, 11.6 feet below the crown. Slide gate in a concrete box on the waterside (WS) slope. (Automatic Board Order (ABO) issued as Permit No. 9532, 1974 - Martin). [Additional Reference(s): DWR Levee Log, 2002. USACE Sacramento O&M Manual 136, March 1960 (HLM 7.73)].

Depression around WS concrete box

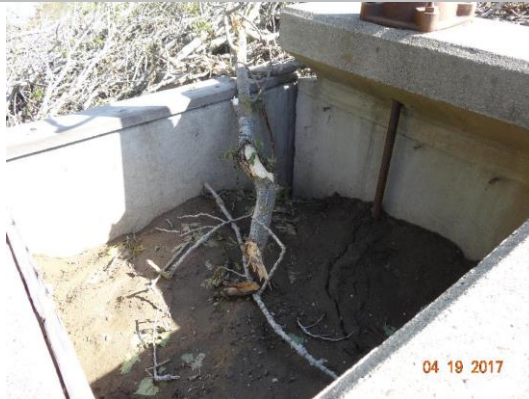
Photo 3 of 3 : UCIP_SP_2017_51695_77010.jpg

FS_ID:51695
DS_ID:17301
EP_NO: 9532
Repair Type: Non-Urgent
Crossing Status: Found
UCIP Comments: 4/19/2017 Abandoned- erosion/depression present around the WS box (DWR Sutter Yard- AFreitag)10/31/2016 Abandoned and erosion still present near WS box.(DWR Sutter Yard-Afreitag)6/1/2016 Appears to be an abandoned crossing.4/1/2015 Silted concrete box on WS. Depression/erosion around concrete box on WS.Silted concrete box on WS. Depression/erosion around concrete box on WS.6/30/2014 Same as last inspection.12/18/2013 Same as last inspection.7/23/2013 Same as last inspection.
FIELD_STRUCT_DESC: *ABANDONED* 36-inch by 48-inch reinforced concrete box drainage culvert through the levee, 11.6 feet below the crown. Slide gate in a concrete box on the waterside (WS) slope. (Automatic Board Order (ABO) issued as Permit No. 9532, 1974 - Martin). [Additional Reference(s): DWR Levee Log, 2002. USACE Sacramento O&M Manual 136, March 1960 (HLM 7.73)].

WS concrete box full of silt.

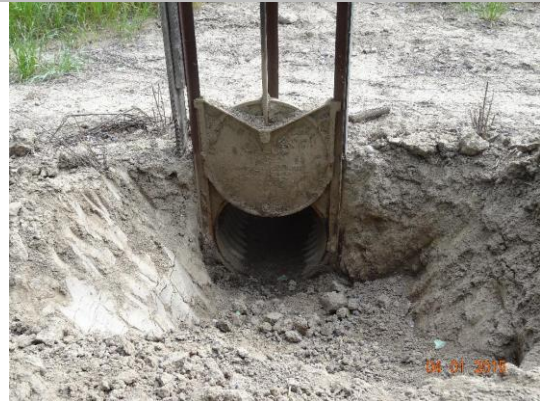
Photo 3 of 3 : UCIP_SP_2017_51726_73649.jpg

FS_ID:51726
 DS_ID:17327
 EP_NO: 9528
 Repair Type: Non-Urgent
 Crossing Status: Found
 UCIP Comments: 4/19/2017 Abandoned- needs to be done so properly. (DWR Sutter Yard- Afreitag)10/31/2016 Abandoned. (DWR Sutter Yard- Afreitag)6/13/2016 Pipe was internally cleaned and camera inspected by Nor-Cal Pipeline Services on 10/29/2015. Pipe length through levee is 75.1ft long. The inspection showed some signs of rust but no holes or other deterioration were found. Pics of exposed pipe ends were uploaded on 4/1/2015. After the inspection the pipe ends were capped and reburied.4/14/2016- Same as last inspection.4/1/2015- Both ends of pipe have been dug up in preparation for internal camera inspections. Pipe shows some rust but appears to be in decent shape. Only buried slide gate structure found.6/30/2014- Same as last inspection.12/18/2013 Same as last inspection.7/23/2013 Same as last inspection.
 FIELD_STRUCT_DESC: *ABANDONED* 24-inch corrugated metal drainage pipe through the levee, 12.5 feet below the crown. Slide gate on the waterside (WS). (Automatic Board Order (ABO) issued as Permit No. 9528, 1974 - Lamb). [Additional Reference(s): DWR Levee Log, 2002. USACE Sacramento O&M Manual 136, March 1960 (HLM 8.59)].

WS pipe end

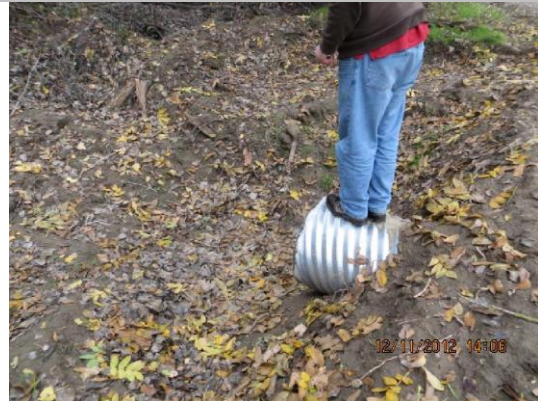
Photo 2 of 3 : UCIP_SP_2017_51731_47241.jpg

Waterside view: overview of CMP pipe

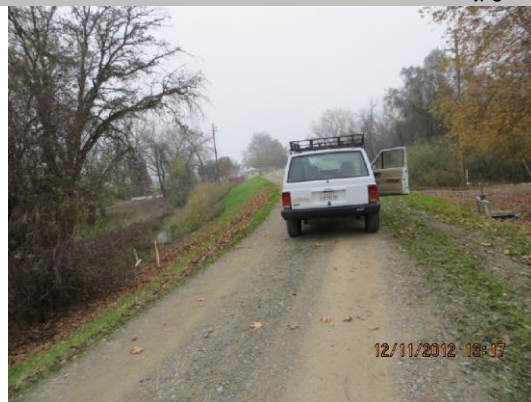
Photo 1 of 3 : UCIP_SP_2017_51734_47263.jpg

Crown view: overview (both sides of the levee)

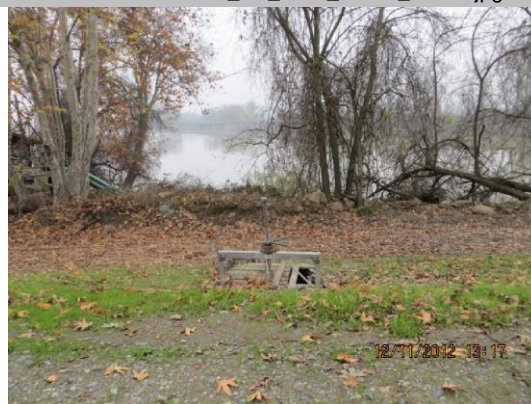
Photo 2 of 3 : UCIP_SP_2017_51734_47262.jpg

Waterside view: overview of CMP riser

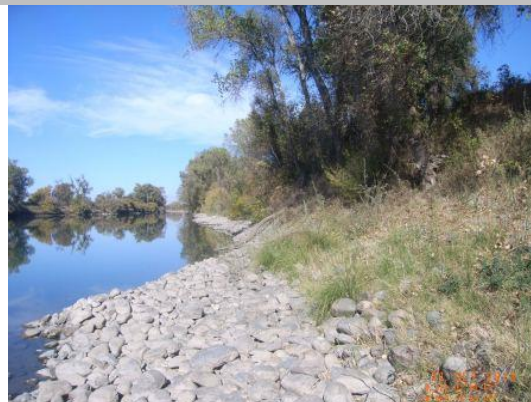
Photo 1 of 1 : SP_2017_ST0003_264_8_20170315_00007.jpg

LM Start	11.53	Rating **	M	Issue No.	8
LM End	11.79	Issue Type +	Ma	Location *	WS
Category	Supplemental			GPS Latitude/Longitude	
				Start	End
Item	2015 USACE Erosion Survey, DRAFT			39.279910 °	39.283853 °
				-122.018221 °	-122.016113 °
DWR ID	DWR_ST0003_01_s_2016_8				
Comment Code					
Inspector Comment					
2008 - Large rotational/mass failure in the bank with tree slump. 2009 - Minimal new erosion, the tree is leaning further into the river. 2011 - Site extended downstream. 2012 - Minor new erosion and tree roots are further exposed. 2015: Last observed in 2013. [2015 Site ID: SAC_152-6_L]

USACE 2013 Photo #1

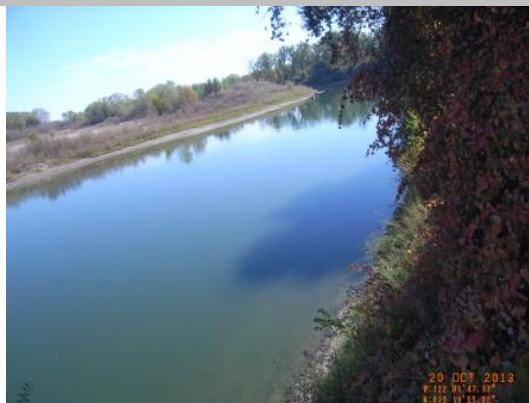
Photo 1 of 1 : SP_2017_ST0003_264_1_20170315_00001.jpg

LM Start	11.85	Rating **	M	Issue No.	1
LM End	11.90	Issue Type +	Ma	Location *	WS
Category	Supplemental			GPS Latitude/Longitude	
				Start	End
Item	2015 USACE Erosion Survey, DRAFT			39.331447 °	39.332716 °
				-122.029440 °	-122.029953 °
DWR ID	DWR_ST0003_01_s _ 2016_1				
Comment Code					
Inspector Comment					
2004 - Slowly eroding but near vertical with no vegetation to hold it.					
2005 - Erosion is close to levee toe but not into the levee section yet.					
2010 - Some new toe scour. 2015: Last observed in 2013. [2015 Site ID: SAC_157-7_R]

USACE 2013 Photo #1

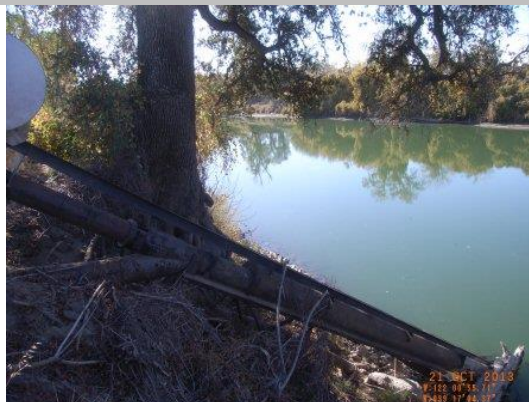
Photo 1 of 1 : SP_2017_ST0003_264_13_20170315_00010.jpg

LM Start	11.85	Rating **	M	Issue No.	13
LM End	11.90	Issue Type +	Ma	Location *	WS
Category	Supplemental			GPS Latitude/Longitude	
				Start	End
Item	2015 USACE Erosion Survey, DRAFT			39.284568 °	39.285298 °
				-122.015690 °	-122.015208 °
DWR ID	DWR_ST0003_01_s _ 2016_13				
Comment Code					
Inspector Comment					
2006 - Large rotational/mass failure in the bank with tree slump. Tough clayey toe material. 2007 - Site is between stone revetments with a pump station at the downstream end. 2010 - Erosion is into the levee toe. 2011 - Minor new erosion. 2012 - Minor new erosion. 2015: Last observed in 2013. [2015 Site ID: SAC_152-8_L]

USACE 2013 Photo #1

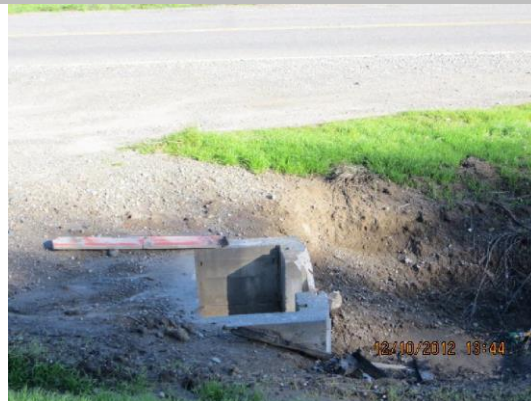
Photo 3 of 3 : UCIP_SP_2017_51752_47360.jpg

Landside view: overview of distribution box

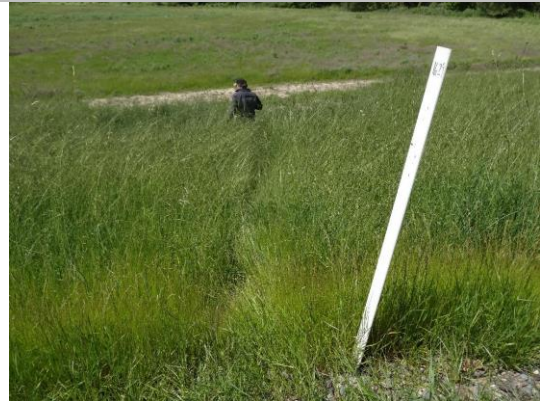
Photo 1 of 3 : UCIP_SP_2017_51759_75096.jpg

View from crown down WS slope at location of crossing.

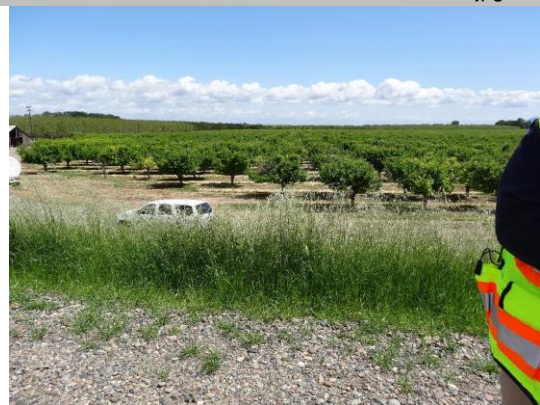
Photo 2 of 3 : UCIP_SP_2017_51759_75097.jpg

View of LS from crown at location of crossing.

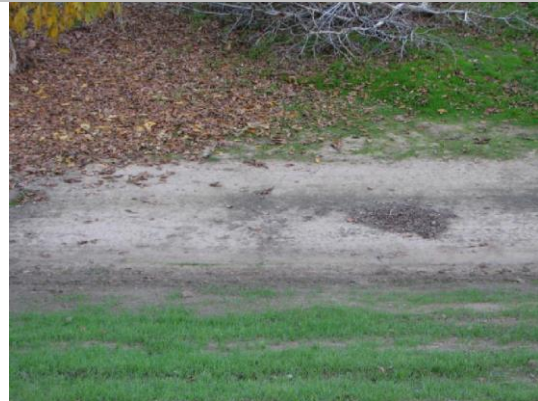
Photo 1 of 3 : UCIP_SP_2017_51762_47384.jpg

Landside view: overview. No pipe found.

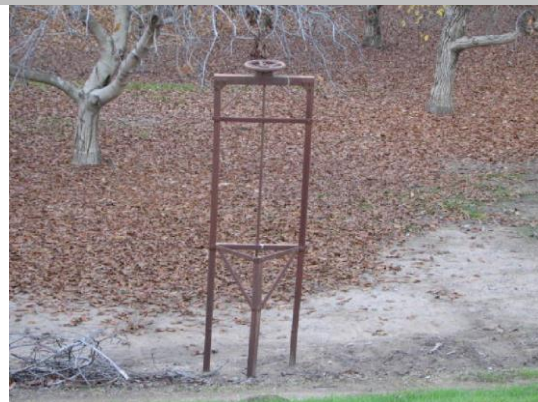
Photo 2 of 3 : UCIP_SP_2017_51762_47386.jpg

Waterside view: slide gate steel structure

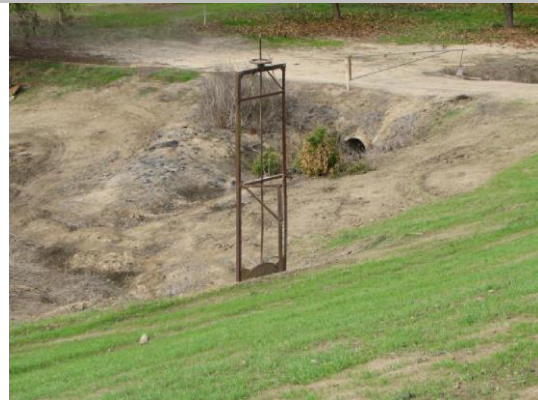
Photo 1 of 3 : UCIP_SP_2017_51770_47399.jpg

Comment Code					
Inspector Comment					
FS_ID:51770 DS_ID:17345 EP_NO: N/A Repair Type: No Action Needed Crossing Status: Found UCIP Comments: 4/20/2017 Crossing appears to be in good condition. (DWR Sutter Yard- A Freitag)11/1/2016 Crossing appears to be in good condition. (DWR Sutter Yard- A Freitag)6/16/2016 Pipe was internally cleaned and camera inspected on 11/19/2015 by Nor-Cal Pipeline Services. Pipe is 155ft in total length and the inspection showed some minor rusting but no holes or other deformations were found. Pipe is still used by the landowner for irrigation and the sloughing near the WS end was repaired and rockered to prevent future sloughing or erosion.4/14/2016 Sloughing repaired by Sutter Yard with rock revetment.4/2/2015 Same as last inspection. Pipe has been selected for internal camera inspection. Sloughing at outlet and levee slope is damaged due to sloughing.7/2/2014 It is not an abandoned crossing. Sloughing at outlet and levee slope is damaged due to sloughing.12/19/2013 Same as last inspection.7/24/2013 Same as last inspection. FIELD_STRUCT_DESC: 36-inch corrugated metal drainage pipe through the levee, 20 feet below the crown. Slide gate at the waterside (WS) toe. [Additional Reference(s): DWR Levee Log, 2002. USACE Sacramento O&M Manual 136, March 1960 (HLM 18.65)]. FS Date: 5/1/2017 10:52:46 AM

Waterside view: overview of sliding gate structure

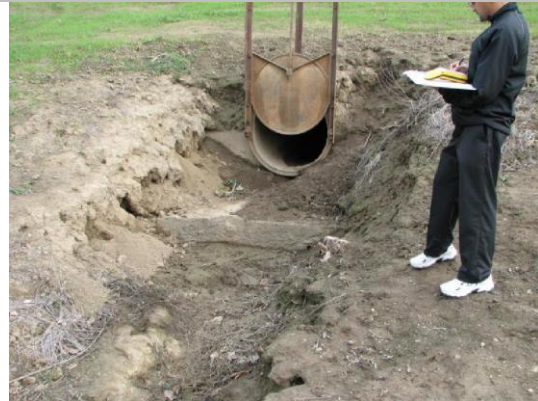
Photo 2 of 3 : UCIP_SP_2017_51770_47398.jpg

Waterside view: outlet pipe with concrete headwall and floor apron.

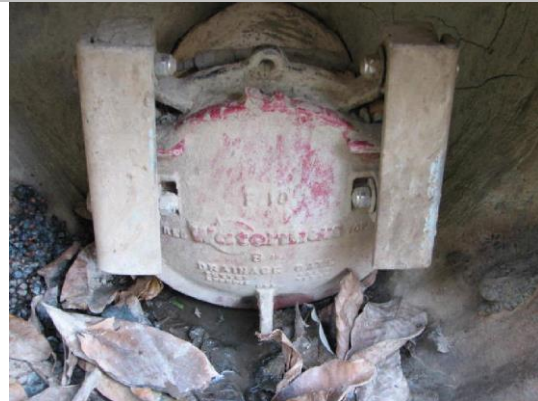
Photo 3 of 3 : UCIP_SP_2017_51771_47440.jpg

FIELD_STRUCT_DESC: 24-inch corrugated metal drainage pipe through the levee, 19 feet below the crown. 8-inch steel pipe sleeved through the 24-inch pipe. Annular space cement grouted. Slide gate at the waterside (WS) toe. Concrete inlet box on the landside (LS). (Automatic Board Order (ABO) issued as Permit No. 9503, 1974 - Baird). [Additional Reference(s): DWR Levee Log, 2002. USACE Sacramento O&M Manual 136, March 1960 (HLM 18.74)].
FS Date: 5/1/2017 10:53:44 AM

Waterside view: 8-inch pipe and drain gate

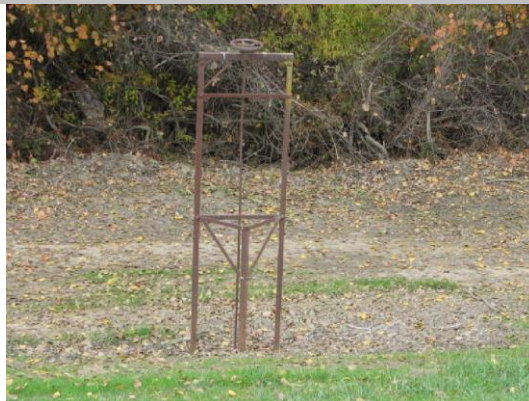
Photo 1 of 3 : UCIP_SP_2017_51773_47447.jpg

Waterside view: overview of abandoned slide gate structure

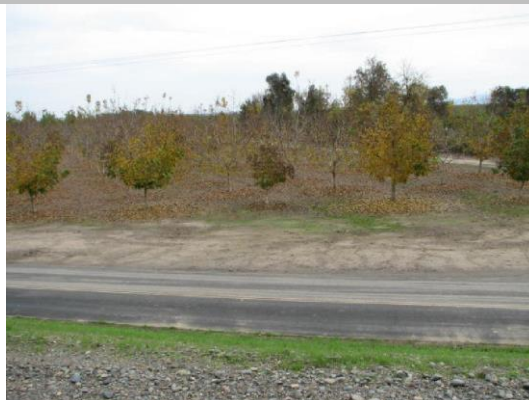
Photo 2 of 3 : UCIP_SP_2017_51773_47446.jpg

FS_ID:51773
DS_ID:17347
EP_NO: N/A
Repair Type: No Action Needed
Crossing Status: Found
UCIP Comments: 4/20/2017 Abandoned- plugged. (DWR Sutter Yard-AFreitag)11/1/2016 Abandoned/plugged. (DWR Sutter Yard-AFreitag)6/16/2016 Internal camera inspection was done on 11/19/2015 by Nor-Cal Pipeline Servies. Pipe was inspected starting from the WS end and inspected upto the grout plug that is 13.7ft into the pipe. Pipe was then capped and reburied until further abandonment can be achieved.4/2/2015 WS end of pipe was dug up in preparation for internal camera inspection. Only steel slide gate structure found on WS.7/2/2014 Same as last inspection.12/19/2013 Same as last inspection.7/24/2013 Same as last inspection.
FIELD_STRUCT_DESC: *ABANDONED* 36-inch corrugated metal drainage pipe through the levee, 21.7 feet below the crown. Slide gate at the waterside (WS) toe. Pipe grouted on the WS end. [Additional Reference(s): DWR Levee Log, 2002. USACE Sacramento O&M Manual 136, March 1960 (HLM 19.24)].

Landside view: overview (no pipes)

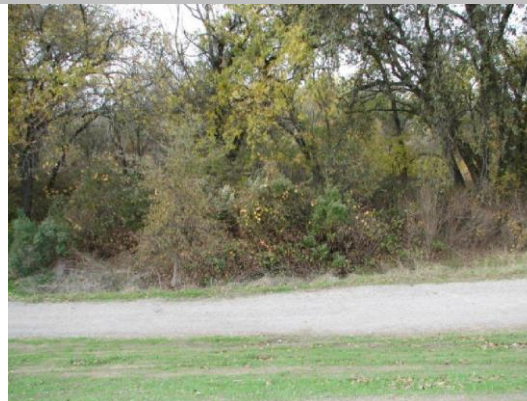
Photo 1 of 3 : UCIP_SP_2017_51775_47449.jpg

FS_ID:51775
DS_ID:17487
EP_NO: N/A
Repair Type: Non-Urgent
Crossing Status: Found
UCIP Comments: 4/20/2017 Abandoned- needs to be done so properly. (DWR Sutter Yard- A Freitag) 11/1/2016 Abandoned. (DWR Sutter Yard- A Freitag) 6/3/2016 Abandoned crossing. 4/2/2015 Same as last inspection. Slide Gate WS not found. An abandoned pump and steel pipe found on WS. A 6 ft x 8 ft concrete distribution box with a CMP found on LS. Box filled with soil. An abandoned crossing. 7/2/2014 Same as last inspection. 12/19/2013 Same as last inspection. 7/24/2013 Same as last inspection.
FIELD_STRUCT_DESC: *ABANDONED* 36-inch corrugated metal drainage pipe through the levee, invert 21.7 feet below the crown. Abandoned pump and steel pipe found on the waterside (WS). 6 foot by 8 foot concrete distribution box with the 36-inch corrugated metal pipe found on the landside (LS). [Additional Reference(s): USACE Sacramento O&M Manual 136, March 1960 (HLM 19.61)].

LM Start	19.55	Rating **	M	Issue No.	190 (cont)
LM End	19.55	Issue Type +	Ma	Location *	LS

Waterside view: overview

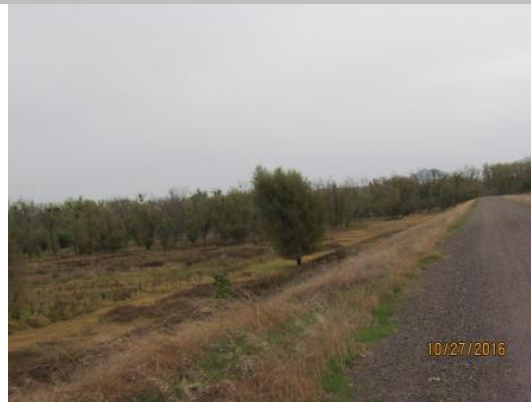
Photo 1 of 1 : SP_2017_ST0003_265_4_20170315_00002.jpg

LM Start	2.02	Rating **	M	Issue No.	4
LM End	2.19	Issue Type +	Ma	Location *	WS
Category	Earthen Levee			GPS Latitude/Longitude	
				Start	End
Item	Vegetation			39.227865 °	39.227868 °
				-121.962233 °	-121.959095 °
DWR ID	DWR_ST0003_02_f_2016_4				
Comment Code					
V1 : Control annual grass and weeds on the levee slopes and easements.					
Inspector Comment

View of the waterside vegetation.

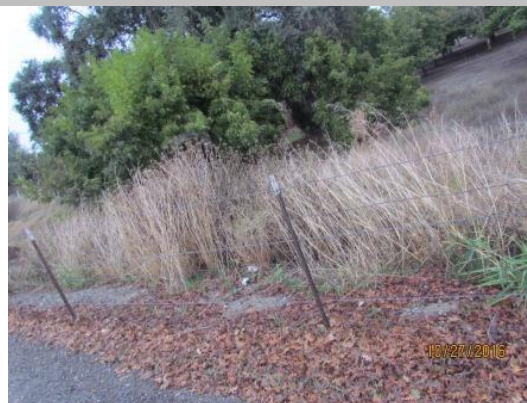
Photo 1 of 1 : SP_2017_ST0003_266_1_20170315_00001.jpg

LM Start	0.01	Rating **	M	Issue No.	1	
LM End	0.04	Issue Type +	Ma	Location *	LS	
Category	Earthen Levee			GPS Latitude/Longitude		
				Start		End
Item	Vegetation			39.236627 °		39.236552 °
				-121.993928 °		-121.993417 °
DWR ID	DWR_ST0003_03_f_2016_1					
Comment Code						
V1 : Control annual grass and weeds on the levee slopes and easements.						
Inspector Comment

View of the landside vegetation.

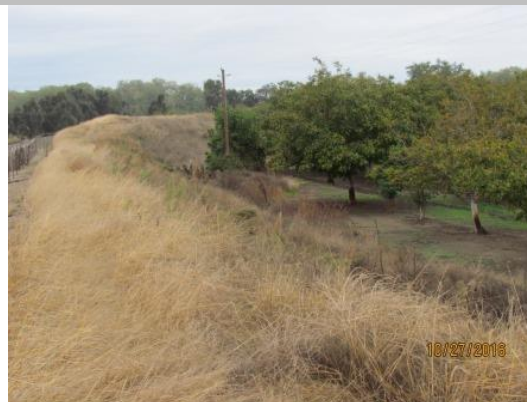
Photo 1 of 1 : SP_2017_ST0003_266_8_20170315_00007.jpg

LM Start	0.19	Rating **	M	Issue No.	8
LM End	0.24	Issue Type +	Ma	Location *	LS
Category	Earthen Levee			GPS Latitude/Longitude	
				Start	End
Item	Vegetation			39.236157 °	39.236147 °
				-121.990713 °	-121.989762 °
DWR ID	DWR_ST0003_03_f_2016_8				
Comment Code					
V1 : Control annual grass and weeds on the levee slopes and easements.					
Inspector Comment

View of the landside vegetation.

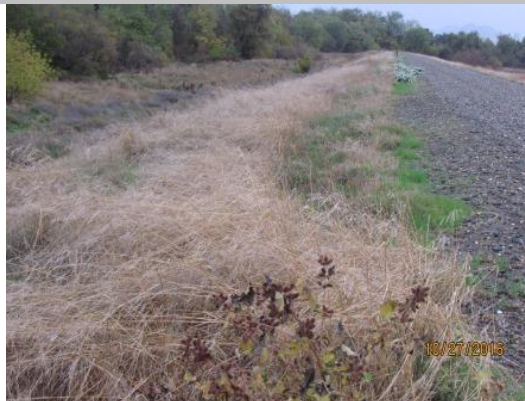
Photo 1 of 1 : SP_2017_ST0003_266_5_20170315_00004.jpg

LM Start	2.04	Rating **	M	Issue No.	5
LM End	2.29	Issue Type +	Ma	Location *	LS
Category	Earthen Levee			GPS Latitude/Longitude	
				Start	End
Item	Vegetation			39.244948 °	39.244898 °
				-121.963805 °	-121.959117 °
DWR ID	DWR_ST0003_03_f_2016_5				
Comment Code					
V1 : Control annual grass and weeds on the levee slopes and easements.					
Inspector Comment

View of the landside vegetation.

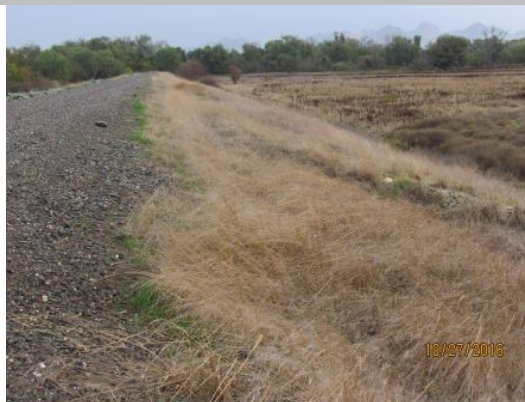
Photo 1 of 1 : SP_2017_ST0003_266_6_20170315_00005.jpg

LM Start	2.04	Rating **	M	Issue No.	6
LM End	2.29	Issue Type +	Ma	Location *	WS
Category	Earthen Levee			GPS Latitude/Longitude	
				Start	End
Item	Vegetation			39.244923 °	39.244898 °
				-121.963775 °	-121.959117 °
DWR ID	DWR_ST0003_03_f_2016_6				
Comment Code					
V1 : Control annual grass and weeds on the levee slopes and easements.					
Inspector Comment

View of the waterside vegetation.

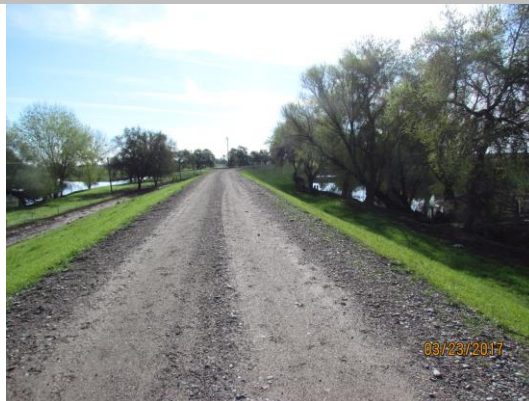
Photo 1 of 1 : SP_2017_ST0003_267_1_20170329_00001.jpg

LM Start	0.05	Rating **	A	Issue No.	1
LM End	0.05	Issue Type +	Ma	Location *	LS
Category	Earthen Levee			GPS Latitude/Longitude	
				Start	End
Item	Vegetation			39.338027 °	39.338027 °
				-122.021193 °	-122.021193 °
DWR ID	DWR_ST0003_04_s_2017_1				
Comment Code					
V1 : Control annual grass and weeds on the levee slopes and easements.					
Inspector Comment					
There is native vegetation on both slopes.

View of native vegetation on both slopes.
